# Failure of Radial (Tainter) Gates Under Normal Operational Conditions

Best Practices in Dam and Levee Safety Risk Analysis

Chapter G-1

US Army Corps  
of Engineers®

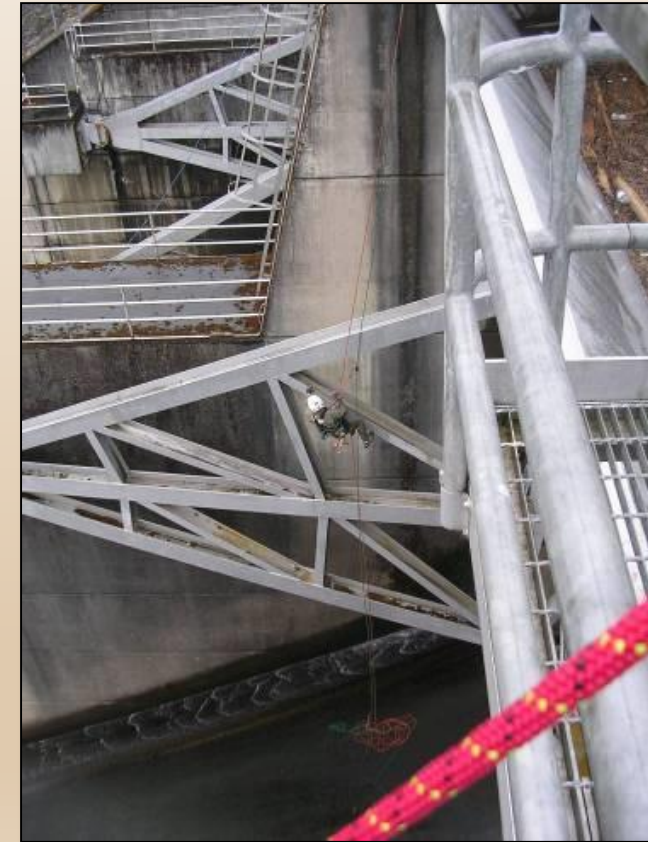
**July 2008 – Climbing inspection of gates 3 & 4**

- Top strut arms and diagonals showed signs of distress.

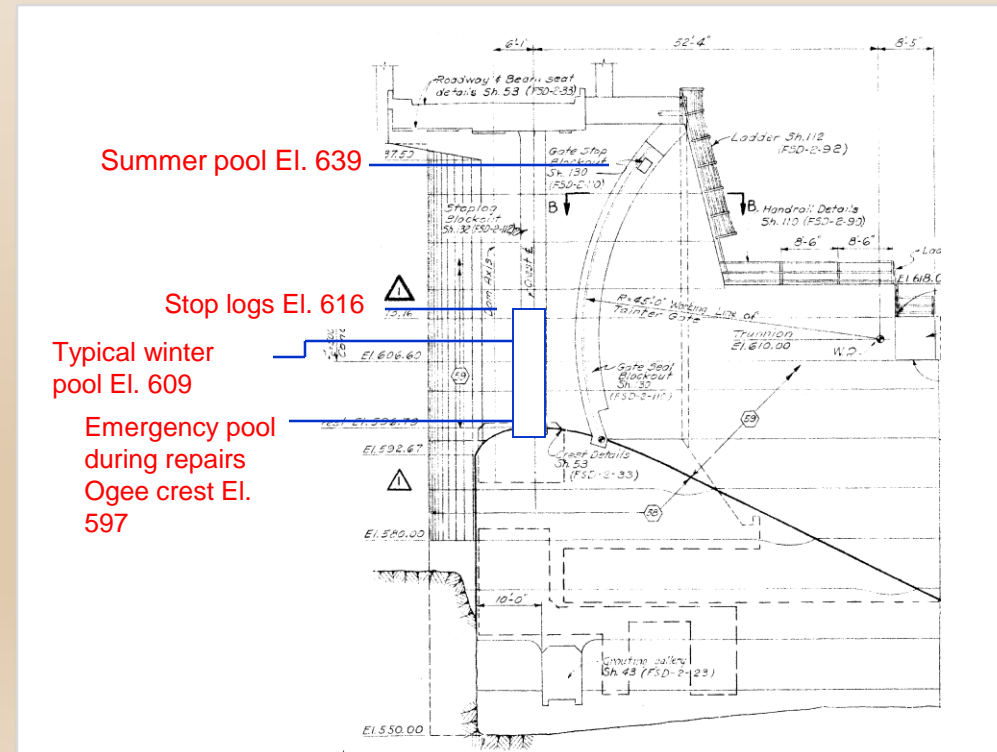
Ranked gates according to condition for priority of use until repairs could be implemented

- Gate 3 – worst damage to struts – do not use
- Gate 1 – damage to struts – do not use
- Gate 2 – some damage to struts - restricted
- Gate 4 – some damage, restricted

Project went to ogee crest operation during repair (run of the river)

Ogee crest required to facilitate repair

- Accepted some flood risk

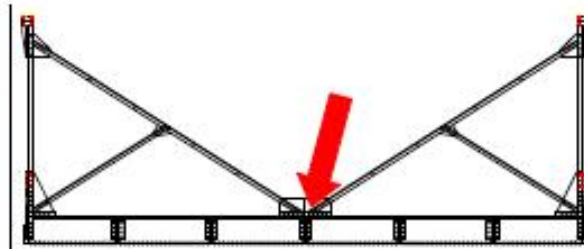
Photo 90: Gate 4 – Heavy corrosion of top horizontal center gusset plate. Up to 100% section loss on downstream edge of plate. Up to 100% section loss of rivets. Welded diagonal strut connections heavily corroded.
